## WOODY VEGETATION AND RIPRAP STABILITY ALONG THE SACRAMENTO RIVER MILE 84.5-119<sup>1</sup>

*F. Douglas Shields, Jr.*<sup>2</sup>

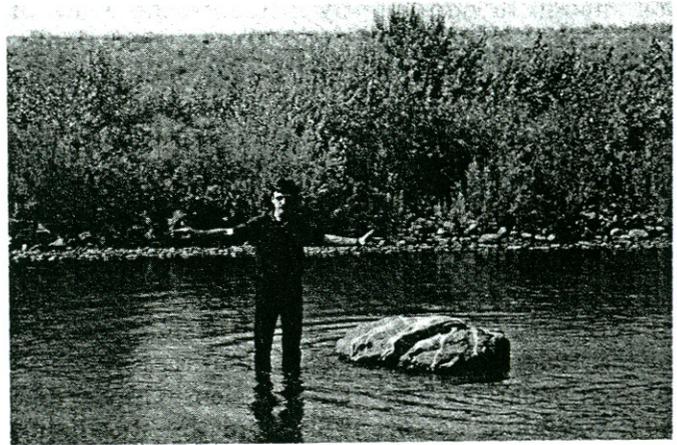
Figure 1. Invasion of Riprap Revetment by Pioneering Woody Species.

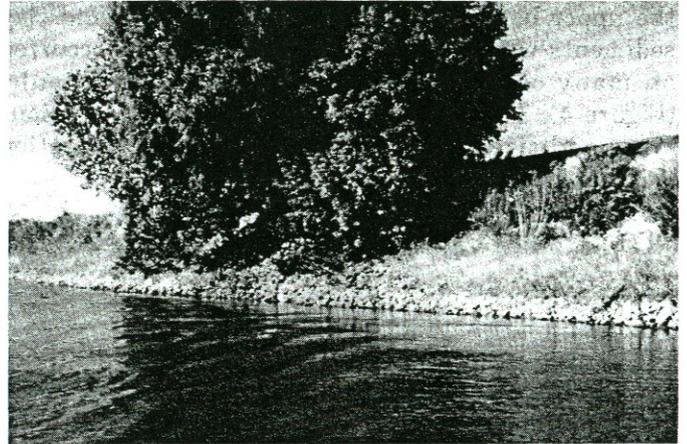
a. Sacramento River Mile 109.25.

Figure 3. Range of Vegetative Cover Found on Study Reach Revetments.
