Response of Fishes and Aquatic Habitats to Sand-bed Stream Restoration Using Large Woody Debris

Pre- and post construction data are presented that describe effects of habitat rehabilitation of Little Topashaw Creek, a sinuous, fourth-order sand-bed stream draining 37 km² in northwest Mississippi. The rehabilitation project, constructed in 2000, consisted of placing 72 large woody debris structures along eroding concave banks and planting 4000 willow cuttings in sandbars. Response was measured by monitoring flow, channel geometry, physical aquatic habitat, and fish populations. Initially, debris structures reduced high flow velocities at concave bank toes, preventing further erosion and inducing deposition. Physical response during the first year following construction included creation of sand berms along eroding banks and slight increases in base flow water width and depth. Fish collections showed assemblages typical of incising streams within the region, but minor initial responses to debris addition were evident. Progressive failure of the structures and renewed erosion were observed during the second year after construction.

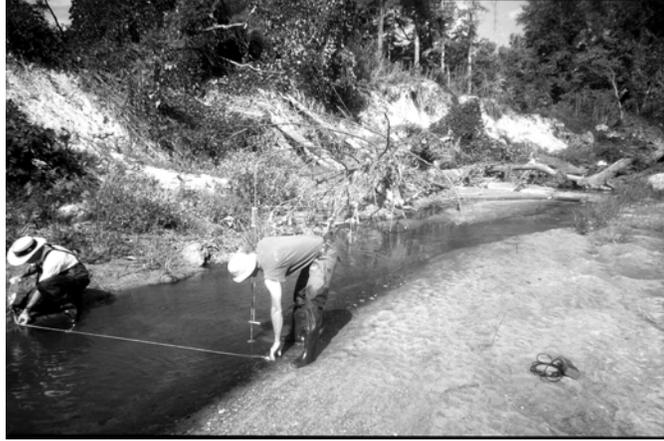
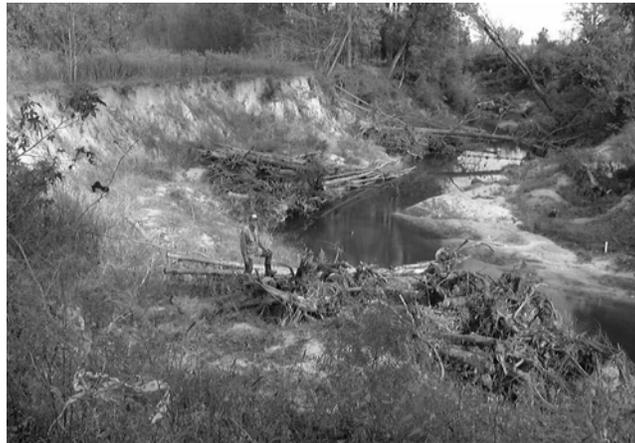
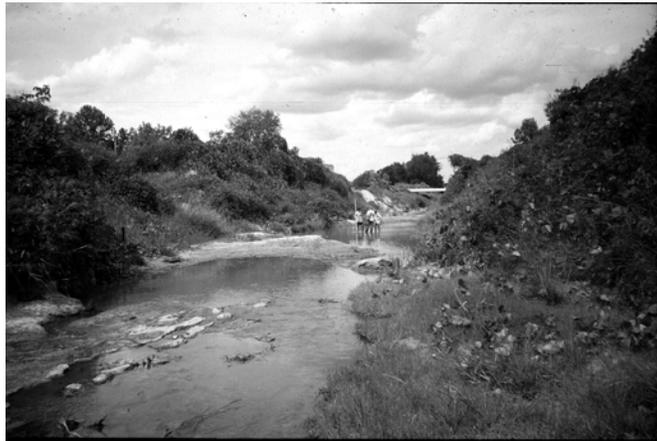
Figure 1. Reaches of Little Topashaw Creek, Mississippi sampled for this study.

a. Upstream.

b. Restored reach showing large woody debris structures on outside of bend one year after construction.

c. Downstream.

A study site was selected along 2 km of Little Topashaw Creek, a fourth-order stream (1:24,000 topographic map) in north central Mississippi draining about 37 km² (Figure 1). Criteria used in site selection included rapid bank erosion, an abundant supply of sandy bed material from upstream, nearby sources of native plant and animal colonists, and an advanced stage of incised channel evolution (Simon & Darby, 1999). The single-thread, meandering channel had an average sinuosity of 2.1, an average slope of 0.002, an average width of 35 m, and an average

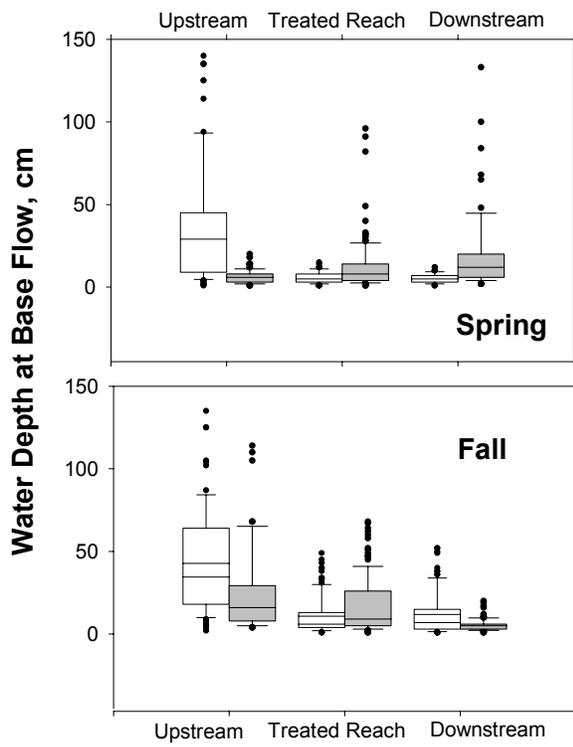
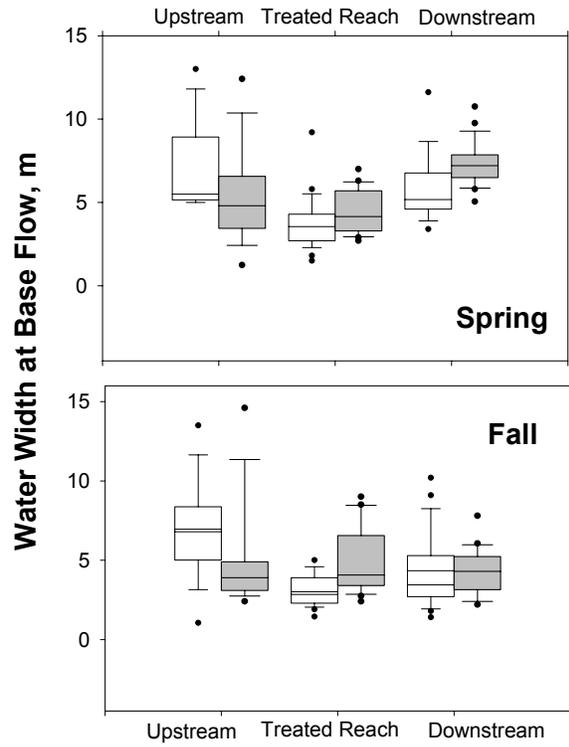
Figure 2. Distribution of water depth and width before and after addition of woody debris to restored reach in late summer 2000.

Physical habitat data collected at similar discharges before (Spring = $0.048 \text{ m}^3 \text{ s}^{-1}$, Fall = $0.018 \text{ m}^3 \text{ s}^{-1}$) and after (Spring = $0.043 \text{ m}^3 \text{ s}^{-1}$, Fall = $0.012 \text{ m}^3 \text{ s}^{-1}$) construction showed that scour adjacent to the woody debris structures and beaver dams resulted in deeper ($\sim 2x$) and slightly wider aquatic habitats at baseflow relative to pre-construction conditions (Figure 2). Untreated reaches up- and downstream became shallower or were unchanged. Water depths were greater in the upstream reach than within the treated reach or downstream due to the presence of several upstream-migrating nickpoints. The upstream reach was typical of a transitional phase that is a precursor of the inferior conditions downstream (Shields et al., 1998). The treated reach became significantly deeper following debris addition ($p < 0.003$, Mann-Whitney Rank Sum Test) while Fall depths were shallower in comparison reaches ($p < 0.002$). Trends in water surface width were not as clear (Figure 2). Width decreased upstream and increased slightly downstream, but increased significantly in the treated reach ($p < 0.001$). Mean water width in the treated reach increased from 3.0 m in Fall 1999 (before addition of woody debris structures) to 5.0 m in the Fall of 2001.

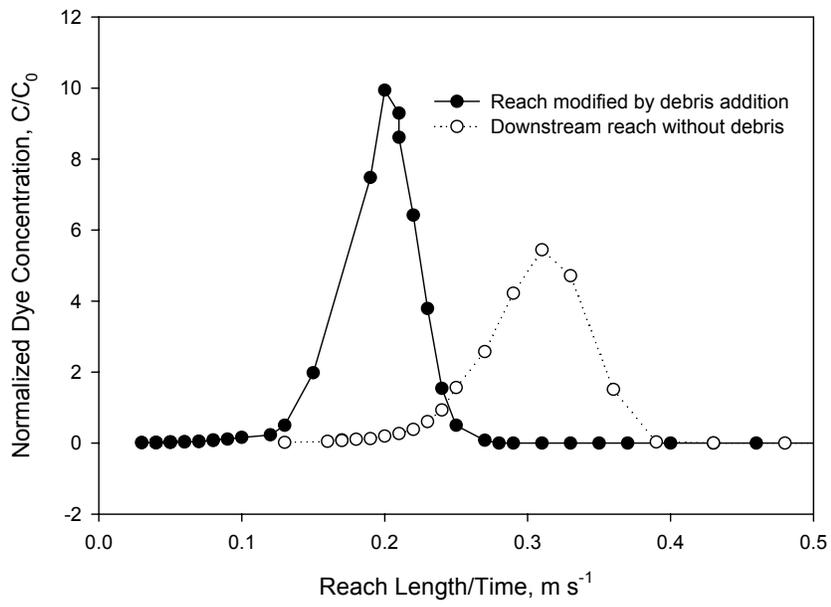
Figure 3. Tracer dye concentration curves following slug injection of fluorescent dye. X-axis represents reach length divided by time.

The dye experiment showed that debris structures increased flow resistance, moderating velocities and increasing retention times (Figure 3). Mean velocity for the treated reach was 17 cm s^{-1} , but 29 cm s^{-1} for the downstream reach. Although the mean velocity was less in the reach treated with debris, dispersion was nearly the same for both reaches, as evidenced by the width of the dye curves in Figure 3.

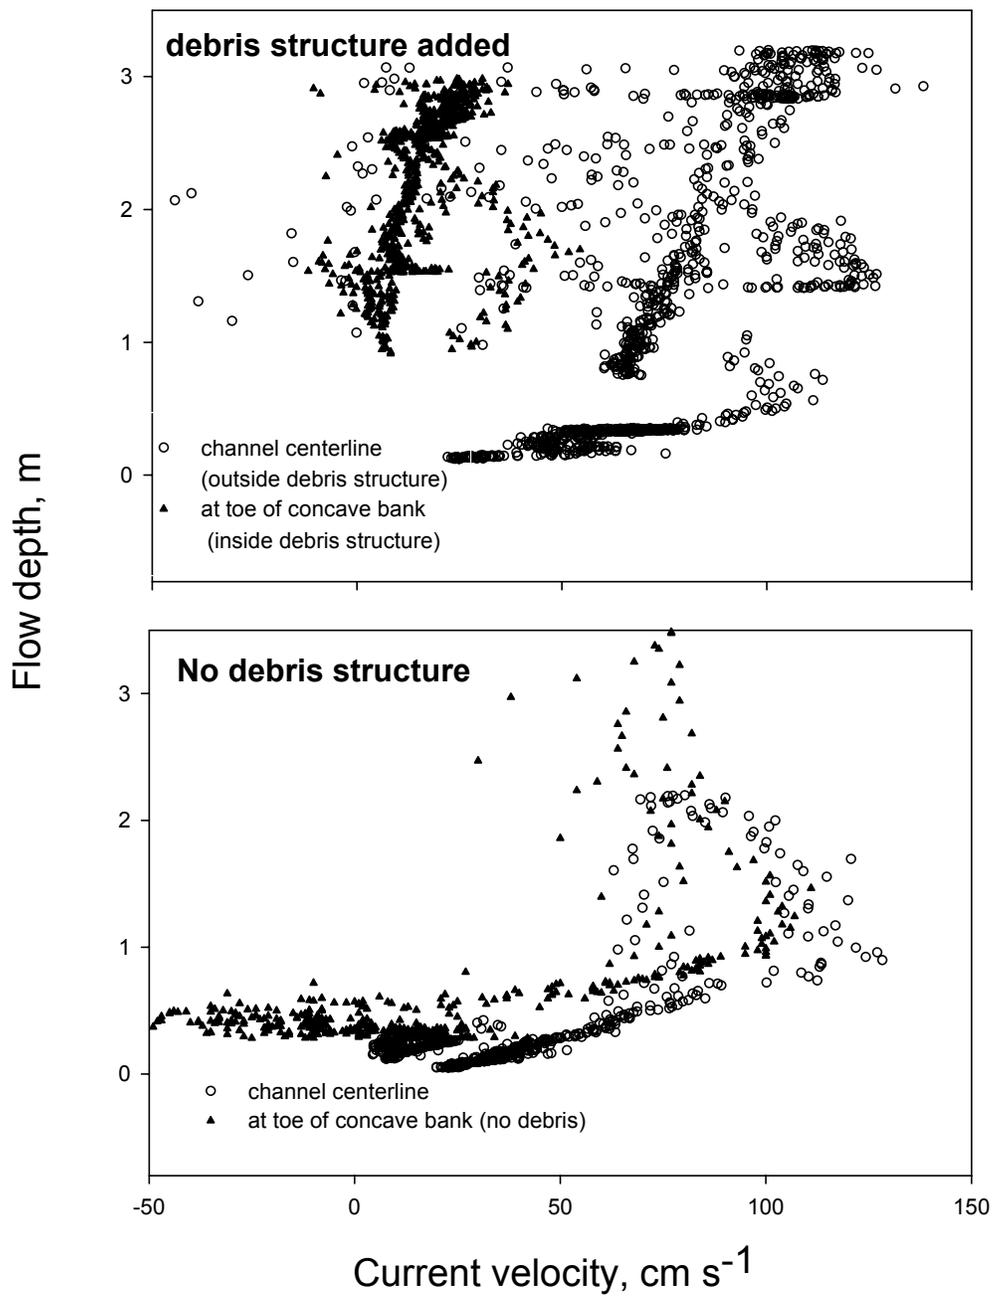
Figure 4. Effect of large woody debris structures on high flow velocities. Velocity measured by acoustic-doppler loggers is plotted on the x-axis against simultaneous records of flow depth plotted on the y-axis for locations within bends with (top) and without (bottom) debris structures along the outside of the bend.

Acoustic-Doppler loggers recorded velocities within debris structures that were only 50% to 60% as great as those in the channel adjacent to the structure or in the bend without debris structures

(Figure 4). Velocities within the debris structure were generally less than 30 cm s^{-1} , and usually below 10 cm s^{-1} , even during events that were large enough to produce flow depths $> 3 \text{ m}$. Events with depths of only $\sim 1 \text{ m}$ produced velocities $> 100 \text{ cm s}^{-1}$ in the bend without debris structures. Habitat preferences of centrarchids and ictalurids generally lie within the 10 to 50 cm s^{-1} range (e.g., Stuber et al., 1982, McMahon and Terrell 1982).

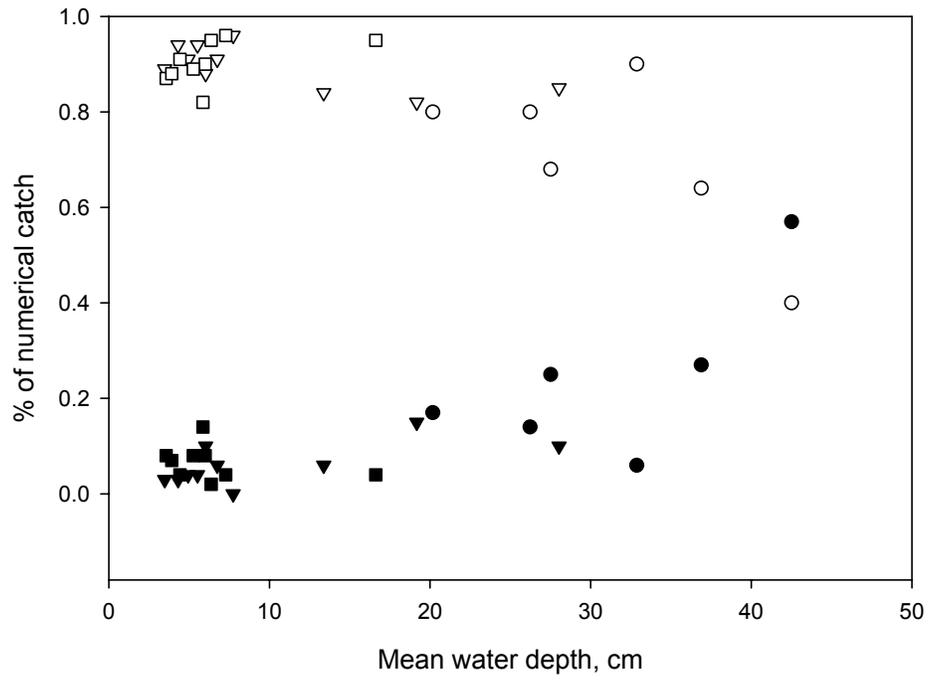
Figure 5. Response of cyprinids (white symbols) and centrarchids (black symbols) to changes in mean water depth. The upstream, restored, and downstream reaches are represented by circles, triangles, and squares, respectively.

Changes in fish population density, average size, and community structure (Table 1) mirrored trends observed in other incised stream ecosystems (Shields et al., 1997 and 1998). Collections were dominated by cyprinids (90% of numbers, 64% of biomass) and centrarchids (6% of numbers, 27% of biomass), but the relative dominance of cyprinids was inversely related to the mean water depth ($r^2 = 0.30$, $p = 0.002$) (Figure 5). Opposite trends were indicated for numbers and biomass of the centrarchids with $r^2 = 0.59$ and 0.54 , for the association between percent of numerical and biomass catch, respectively, and mean depth ($p < 0.00005$). Addition of pool habitat following debris addition increased the fraction of numbers and biomass comprised by centrarchids in the treated reach from 3% to 10% and from 13% to 23%, respectively. Species richness was unaffected by debris addition, but the average number of species per 150-m reach increased in all three zones (upstream, within the treated reach, and downstream) following debris addition (Table 1). Three species typically associated with deeper habitats were captured in the treated reach following debris addition but not before (*Micropterus salmoides*, *Lepomis megalotis*, *Ictalurus punctatus*), and *M. salmoides* was found only in the restored reach. Although changes in the size of centrarchids were not statistically significant ($p > 0.16$, Mann-Whitney Rank Sum Test) in any of the zones, only one of the 27 centrarchids captured in the two years before debris addition was longer than 10 cm, but 4 of the 40 captured afterward were longer than 10 cm.
